Preventing pitting and crevice corrosion of offshore stainless steel tubing

Tubing corrosion can lead to perforations and escape of highly flammable chemicals.

Gerhard Schiroky, Swagelok Company; **Anibal Dam**, BP Exploration & Production Inc.; **Akinyemi Okeremi**, Shell International Exploration & Production; and **Charlie Speed**, Consultant

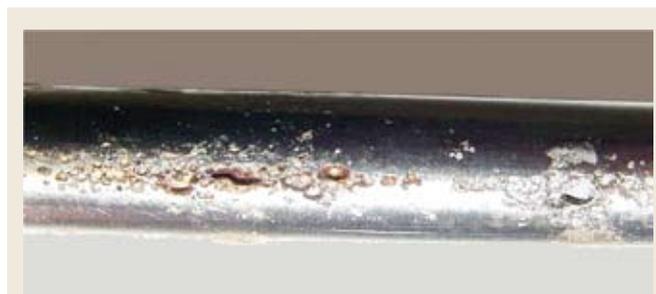
Fig. 1. Pitting corrosion of 316 stainless steel tubing.

In most cases, pitting corrosion of tubing can be readily recognized. Individual shallow pits, and in later stages, deep and sometimes connected pits, can be observed by visual inspection with the unaided eye, Fig. 1. Pitting corrosion starts when the chromium-rich passive oxide film on 316 tubing breaks down in a chloride-rich environment. Higher chloride concentrations and elevated temperatures increase the likelihood for breakdown of this passive film. Once the passive film has been breached, an electrochemical cell becomes active. Iron goes into solution in the more anodic bottom of the pit, diffuses toward the top and oxidizes to iron oxide, or rust. The iron chloride solution concentration in a pit can increase as the pit gets deeper. The consequence is accelerated pitting, perforation of tubing walls and leaks. Pitting can penetrate deep into the tubing walls, creating a situation where tubing could fail.

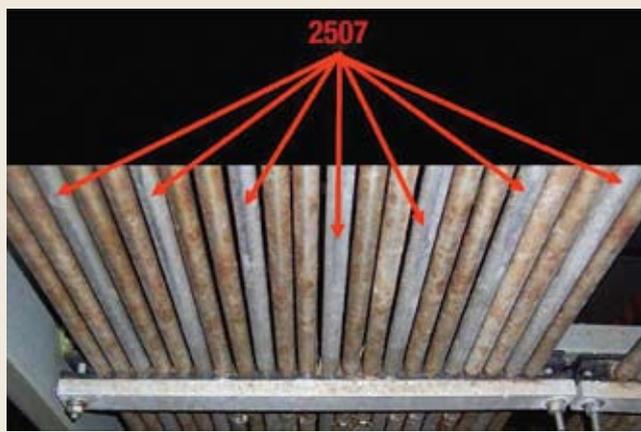
Fig. 2. Image shows 316 stainless steel and alloy 2507 superduplex tubing installed side by side, with the 316 tubing showing extensive corrosion and the superduplex tubing showing none.

The importance of selecting the optimal alloy for an installation is demonstrated in Fig. 2. When installed side by side, austenitic 316 stainless steel tubing experienced heavy corrosion, while no signs of corrosion were detected on alloy 2507 superduplex tubing. In a GOM installation of alloy 2507 tubing, only a very small number of cases of external chloride crevice corrosion damage were identified. Perforations leading to the loss of system fluid containment were not observed. The only crevice corrosion damage involved plastic support strips and neoprene gaskets.

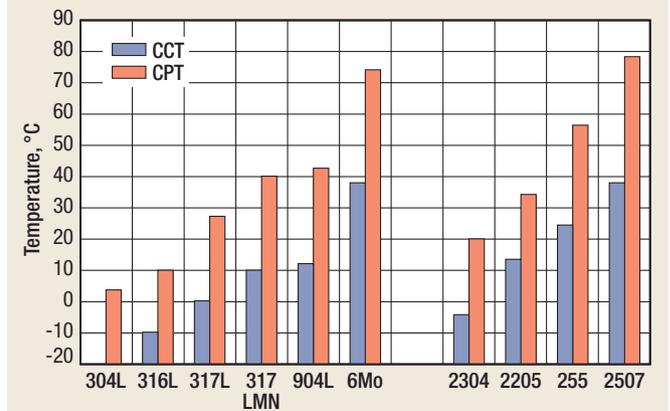
Fig. 3. Bar chart shows critical pitting temperature and critical crevice corrosion temperatures of austenitic and duplex stainless steels. Measured by ASTM G48 in 10% ferric chloride.

ture of several alloys are shown in Fig. 3. The increase in chromium, molybdenum and nitrogen clearly leads to an increase in the CPT and CCT values of austenitic and duplex stainless steels. Also, despite their overall lower content of costly constituents nickel and molybdenum, they offer a similar performance to that of highly alloyed austenitic stainless steels.

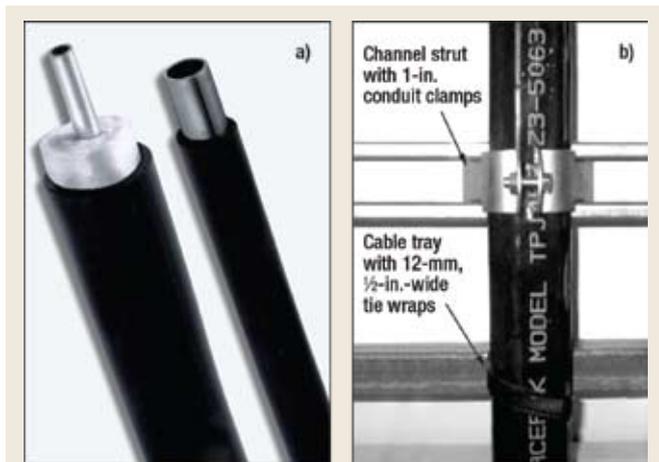
Fig. 4. a) Insulated jacketed tubing and jacketed tubing. b) Installed bundled jacketed tubing, with two appropriate clamping options.

For applications in seawater environments, a tubing alloy that is highly resistant to localized corrosion is not the only option. Alternatively, a less resistant alloy may be used if it is shielded, Fig. 4a. A thermoplastic polyurethane jacket offers adequate protection that can be cost-effectively extruded onto continuous tubing. The jacket must offer reliable protection from corrosive fluids and fulfill a series of additional requirements. The jacket must be durable, i.e., resist impact, abrasion and degradation by UV radiation. It must allow for tubing bending and cost-effective tubing installation, i.e., jacket removal and tubing connections makeup. Once made up, the connections typically have to be protected from the environment using shrink tubing or tape. Without this type of protection, seawater access could cause pitting corrosion of exposed tubing or crevice corrosion in the gap between the tubing and the jacket.

Appropriate tubing clamps must be selected and care taken to prevent clamps from cutting into jackets and sacrificing their protective character, Fig. 4b. An added advantage of jacketed tubing is the possibility to insulate, or heat and insulate, tubing when system fluids must be kept above ambient temperature.

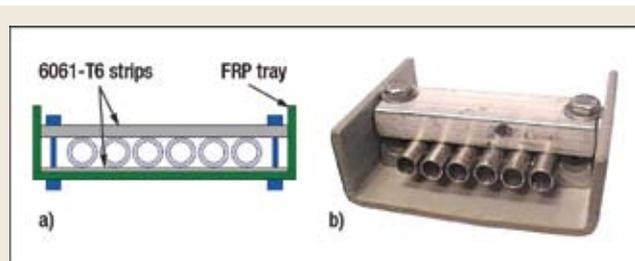
Fig. 5. Schematic (a) and photograph (b) of tubing supports that utilize aluminum alloys.

One of the early approaches to preventing or mitigating crevice corrosion has been the use of marine aluminum alloys in tubing supports and clamps. In the schematic in Fig. 5a, the tubing rests on a thin strip of aluminum alloy that is contained within a fiber-reinforced plastic tray. The tubing is held in place with an aluminum alloy bar. Figure 5b shows an implementation of this design, with the difference that the tubing now rests on corrugated aluminum alloy in sections.

Tubing support structures that utilize aluminum alloys are in use today and appear to be performing well. Galvanic corrosion between aluminum alloy and stainless steel may occur, but the aluminum alloy is more anodic than stainless steel, which means aluminum will corrode preferentially. Once sufficient corrosion has taken place over a number of years, affected aluminum supports and clamps can be replaced while the stainless steel tubing remains in place.

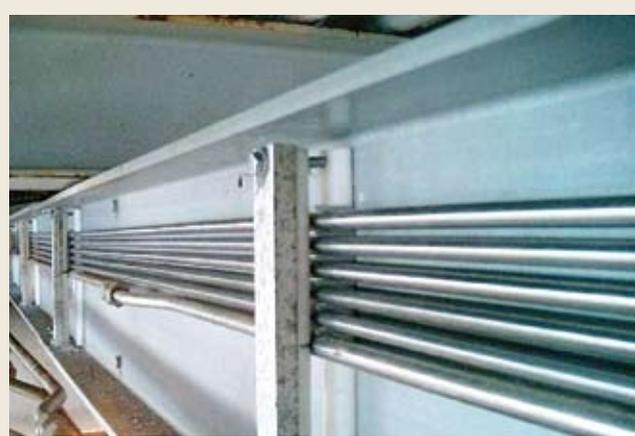
Fig. 6. Installation using 2507 superduplex tubing in the Gulf of Mexico. These tubing supports are based on half-round thermoplastic support rods.

An alternative design has more recently been adopted for the installation of stainless steel tubing. In Fig. 6, tubing is sandwiched between two half-round rods of a thermoplastic material. With the round tubing running perpendicular to the round support rod surface, the crevice contact area is minimized. Theoretically, there should be only one point of contact; however, some plastic deformation of the support rod takes place that results in a finite contact (crevice) area. A benefit of this design is that the supports/clamps allow for differential expansion of tubing and support structure.

Tight crevices between tubing, supports and clamps are difficult to avoid, and hence must be managed. Plastic tubing clamps that lead to large crevice contact areas should not be used. Support and clamping designs that are based on marine aluminum alloys appear to have a good track record in mitigating tubing corrosion. A new support and clamping method for tubing has more recently emerged. In this design, the round surfaces of semi-round thermoplastic rods come into contact with perpendicularly oriented tubing, and the crevice area at the rod/tubing interface is minimized. Recent installations in the Gulf of Mexico have combined this clamping concept with the use of superduplex tubing (Fig. 6) and will generate valuable performance data in the future.
